**AN
ENVIRONMENTAL REVIEW
OF THE
PROPOSED RETURN
OF
U.S. AIR FORCE LEASED PROPERTY,
ASCENSION AUXILIARY AIRFIELD
TO
THE BRITISH GOVERNMENT**

Tim deGavre
Computer Sciences Raytheon

March 26, 2004

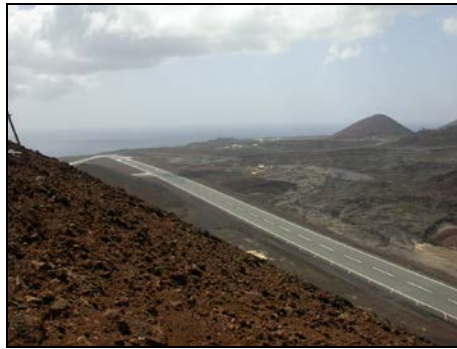
Runway	01432	Built in 1942 and modified with a paved overrun (01435) in 1957, a Taxiway (20600), an Apron (20602), and a High Speed Turn-around (no #), this runway and the associated facilities are used for conducting aircraft operations. A history of the runway has been discussed in Section 1.1.1.
--------	-------	--

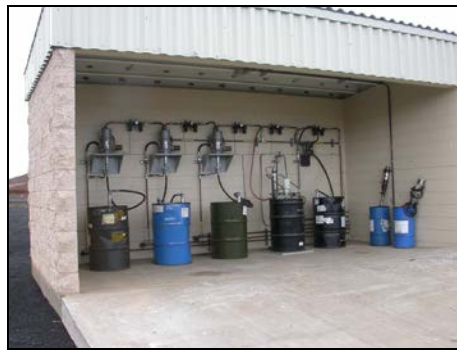
In addition to JP-8 fuel stored in tanks at the facilities to supply the stand-by generators, petroleum products are kept in the Airfield AGE (LOX) storage building. The following products, each contained in a 55-gallon drum, are stored at this site.

- Grease
- Transmission Fluid
- Gear Lube
- JP-8 (Note that diesel fuel is not used in the diesel generators or diesel engines on Ascension AAF. JP-8, to which motor oil is added, is used instead).

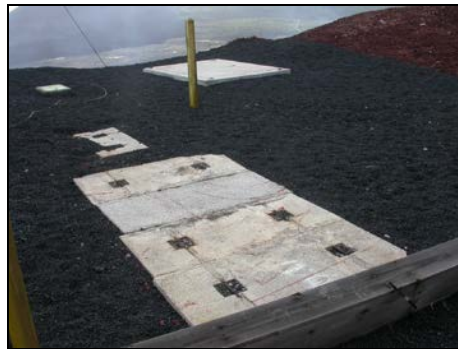
The following buildings have underground septic tanks –

- Command Control Building, Cross Hill
- Homing Beacon Equipment Building
- Rawinsonde Building
- Aircraft AGE Support Building
- Fire Station
